**SITE INSPECTION REPORT
SOUTHERN WOOD PIEDMONT SITE
CHATTANOOGA, TENNESSEE**

TDD NO. F4-8303-06
EPA CONTRACT NO. 68-01-6699

**SITE INSPECTION REPORT
SOUTHERN WOOD PIEDMONT SITE
CHATTANOOGA, TENNESSEE
TND003327400**

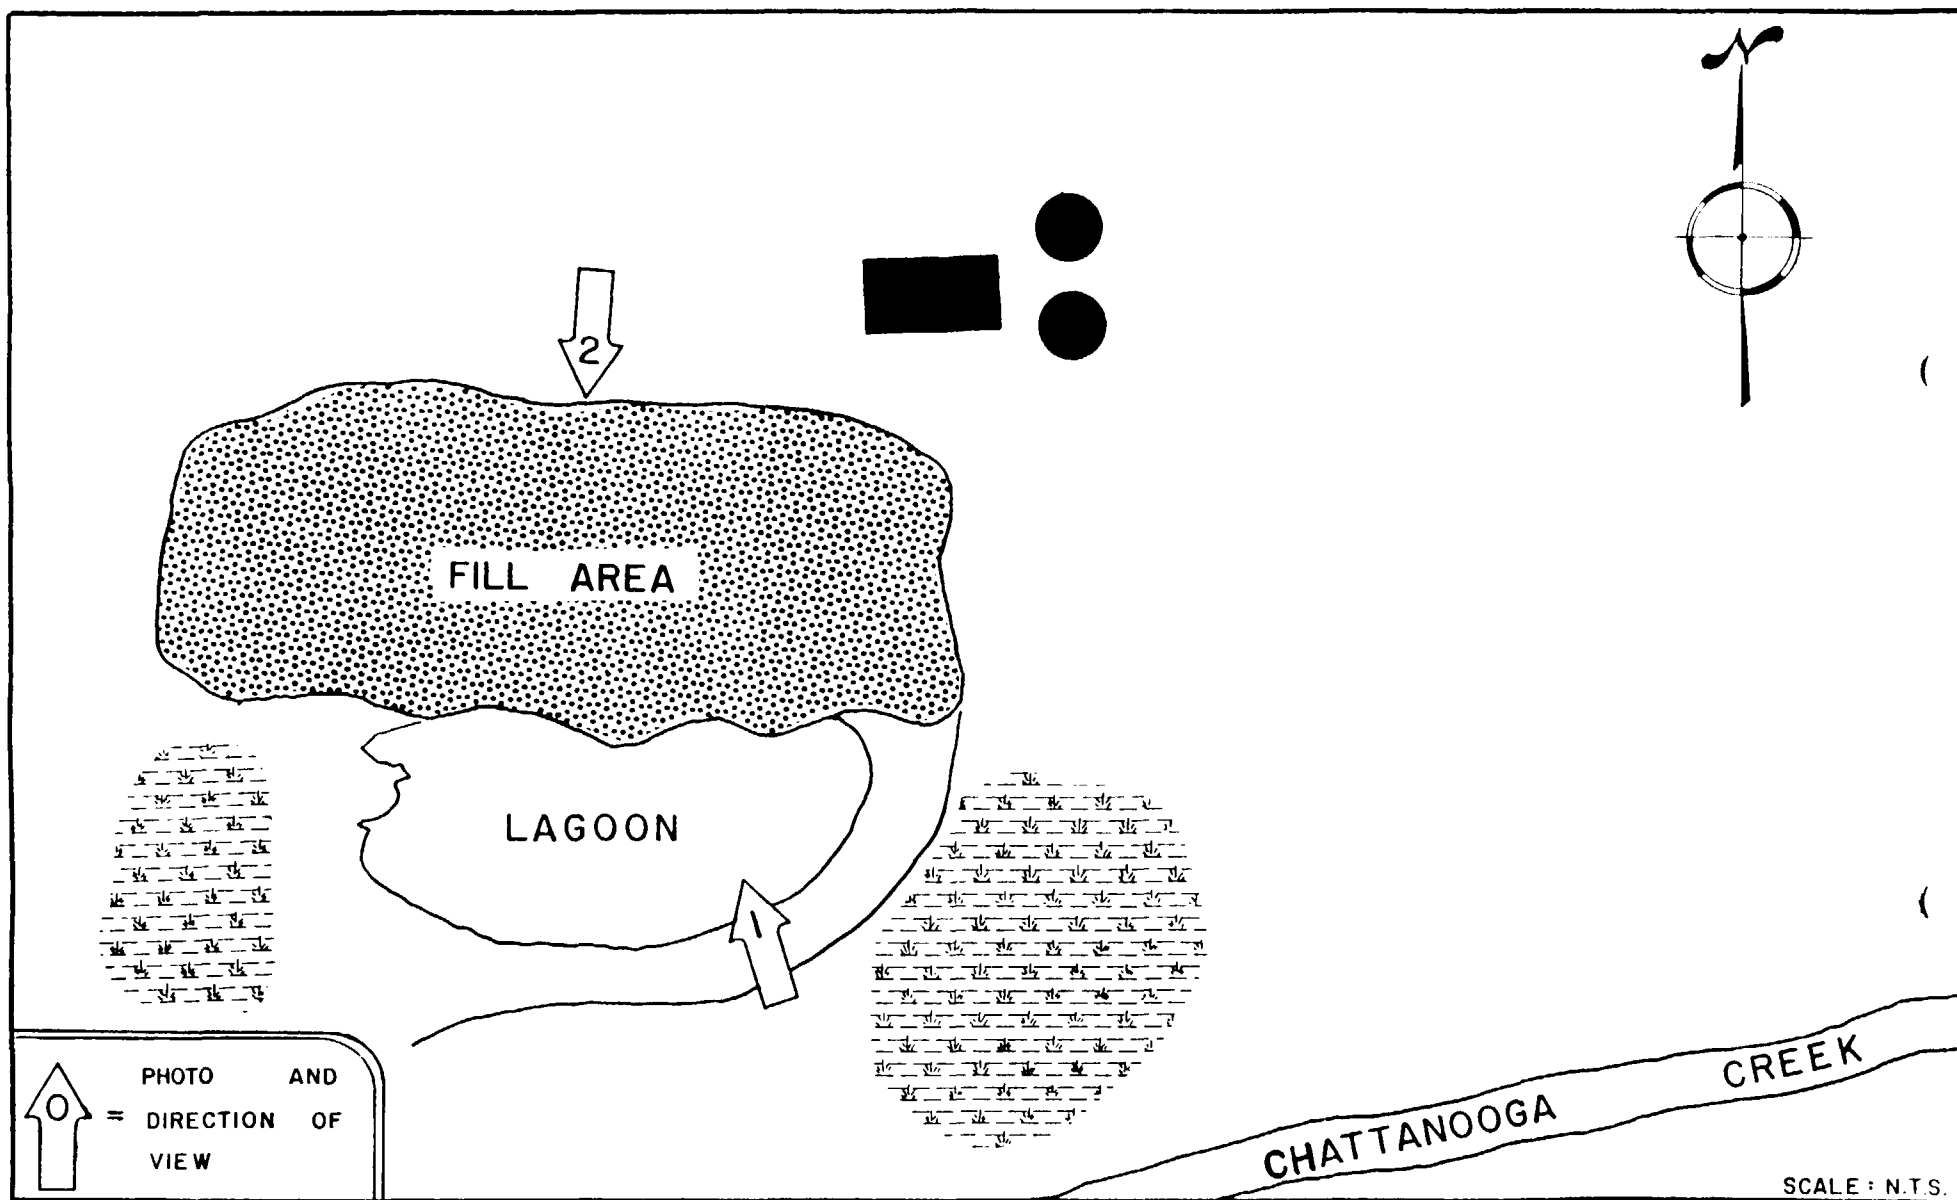
FIGURE 2

Photographs of the disposal area taken during the inspection are attached. Figure 2 indicates the location and direction of view for each photograph.

DISPOSAL AREA
SOUTHERN WOOD PIEDMONT
CHATTANOOGA, TENNESSEE
